Total Land Subsidence in the McMullen Valley, La Paz and Maricopa Counties
Based on ERS-1 and 2 Satellite Interferometric Synthetic Aperture Radar (InSAR) Data
Time Period of Analysis: 4.7 Years 06/08/1992 To 03/13/1997

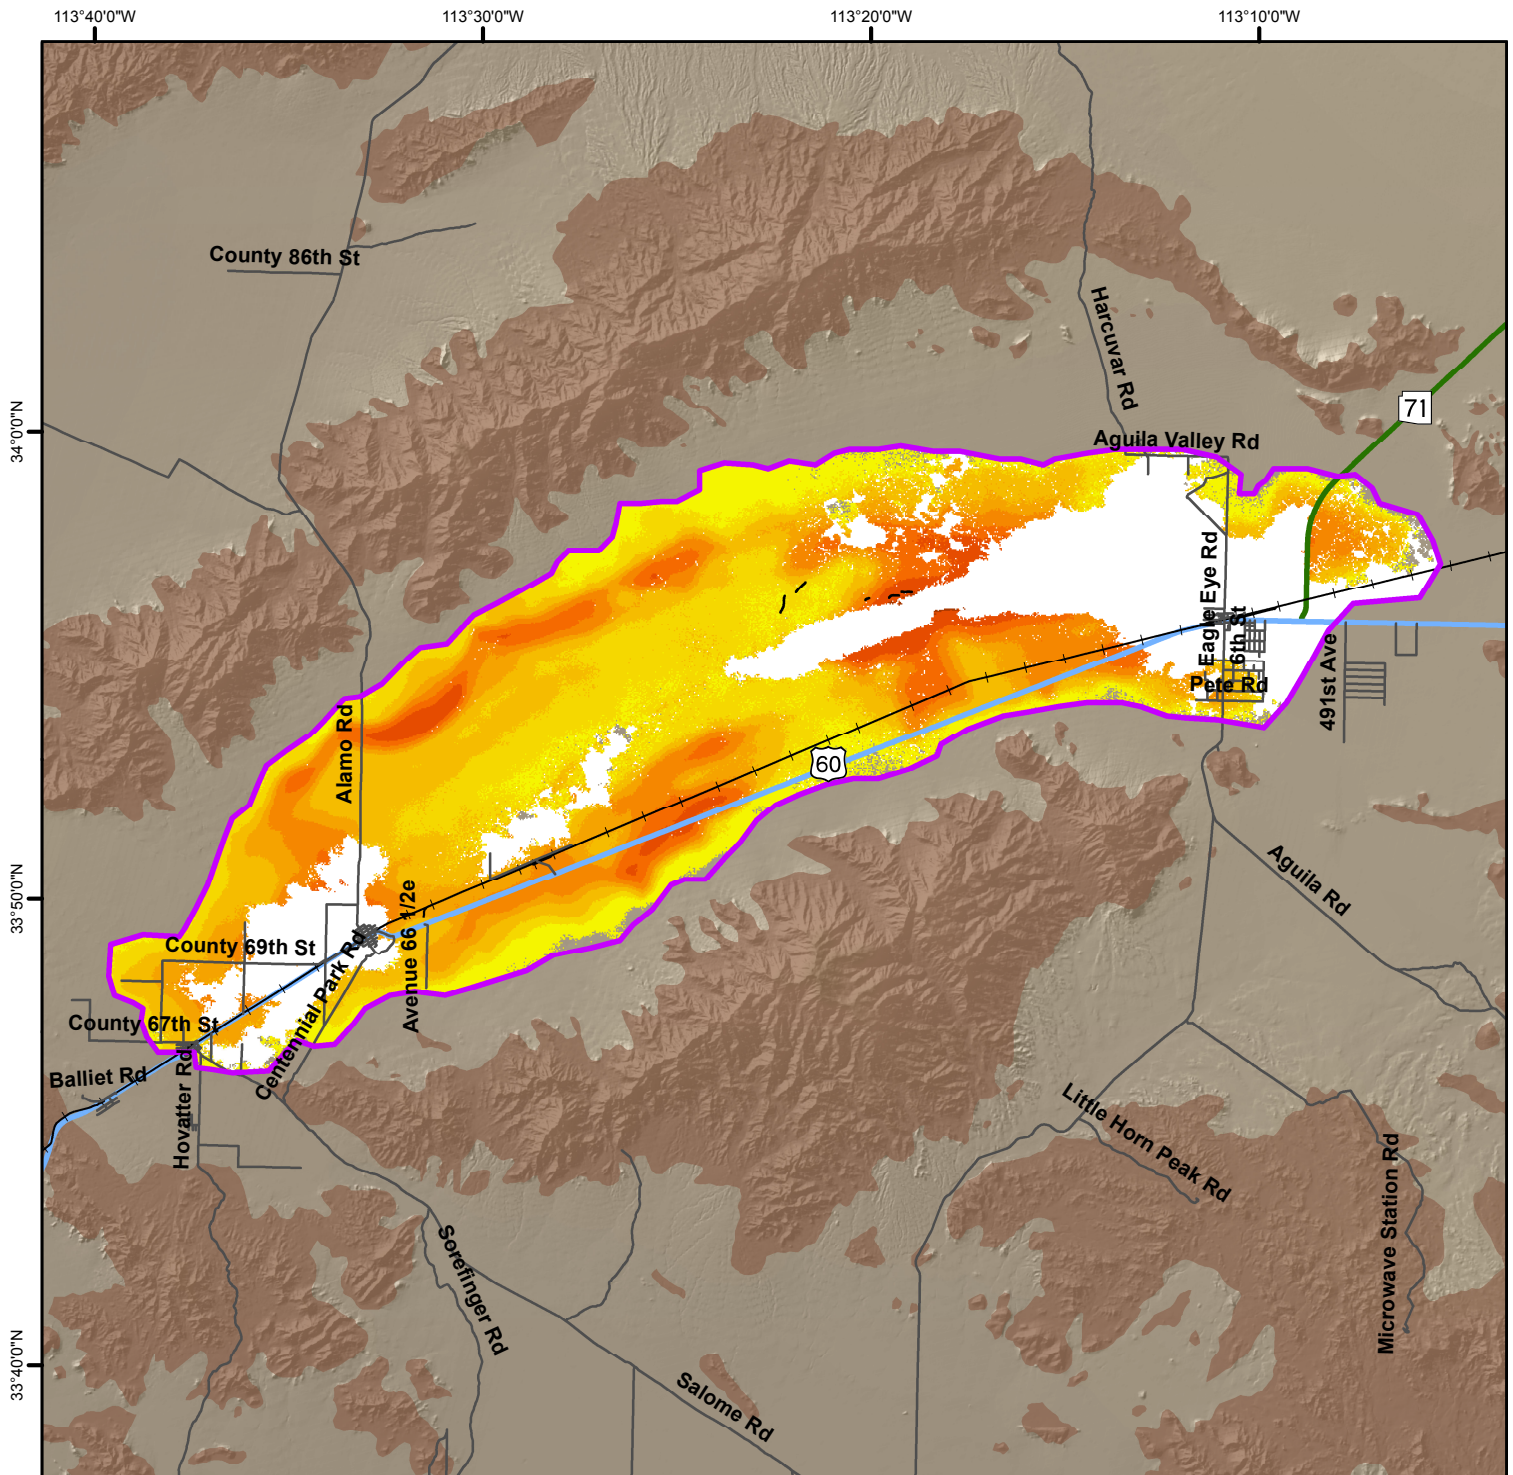
Decorrelation (white areas) are areas where the phase of the received satellite signal changed between satellite passes, causing the data to be unusable. This occurs in areas where the land surface has been disturbed (i.e. bodies of water, snow, agriculture areas, areas of development, etc).
